ERDC TR-01-17

## **Seismic Testing of a 1/20 Scale Model of Koyna Dam**

November 2001

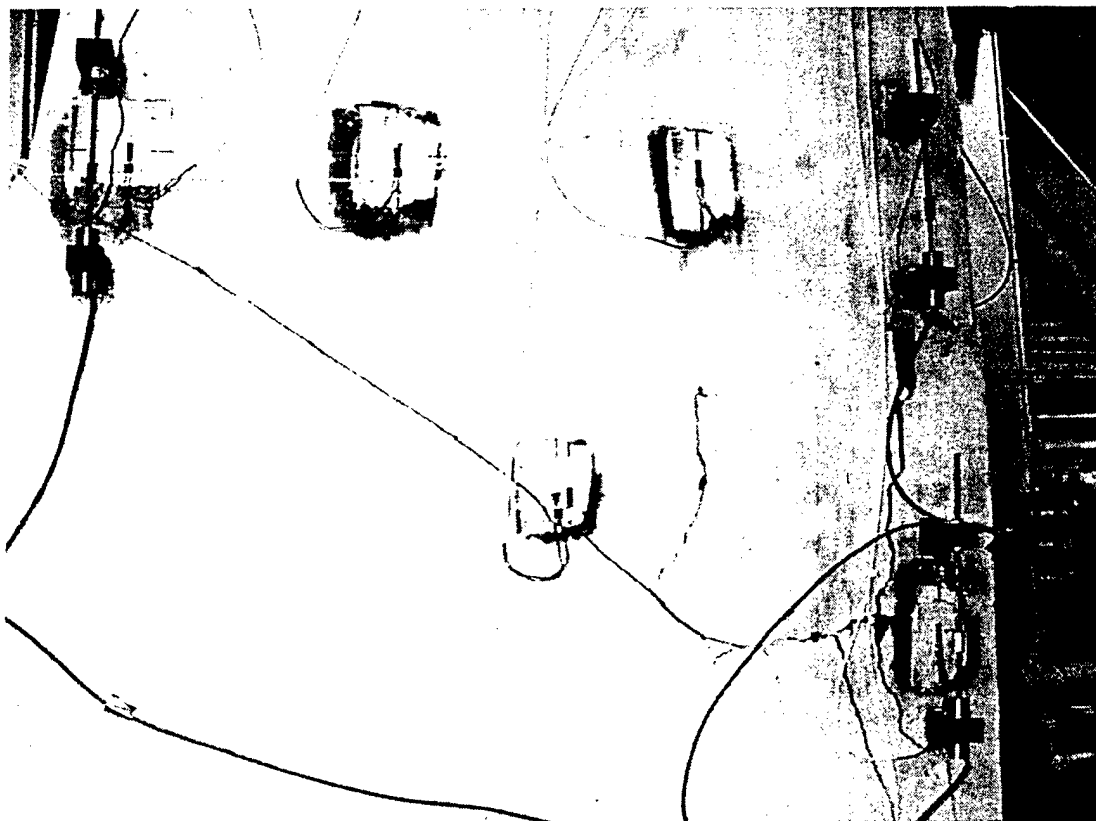
Figure 38. A closer view of the crack on the back face.

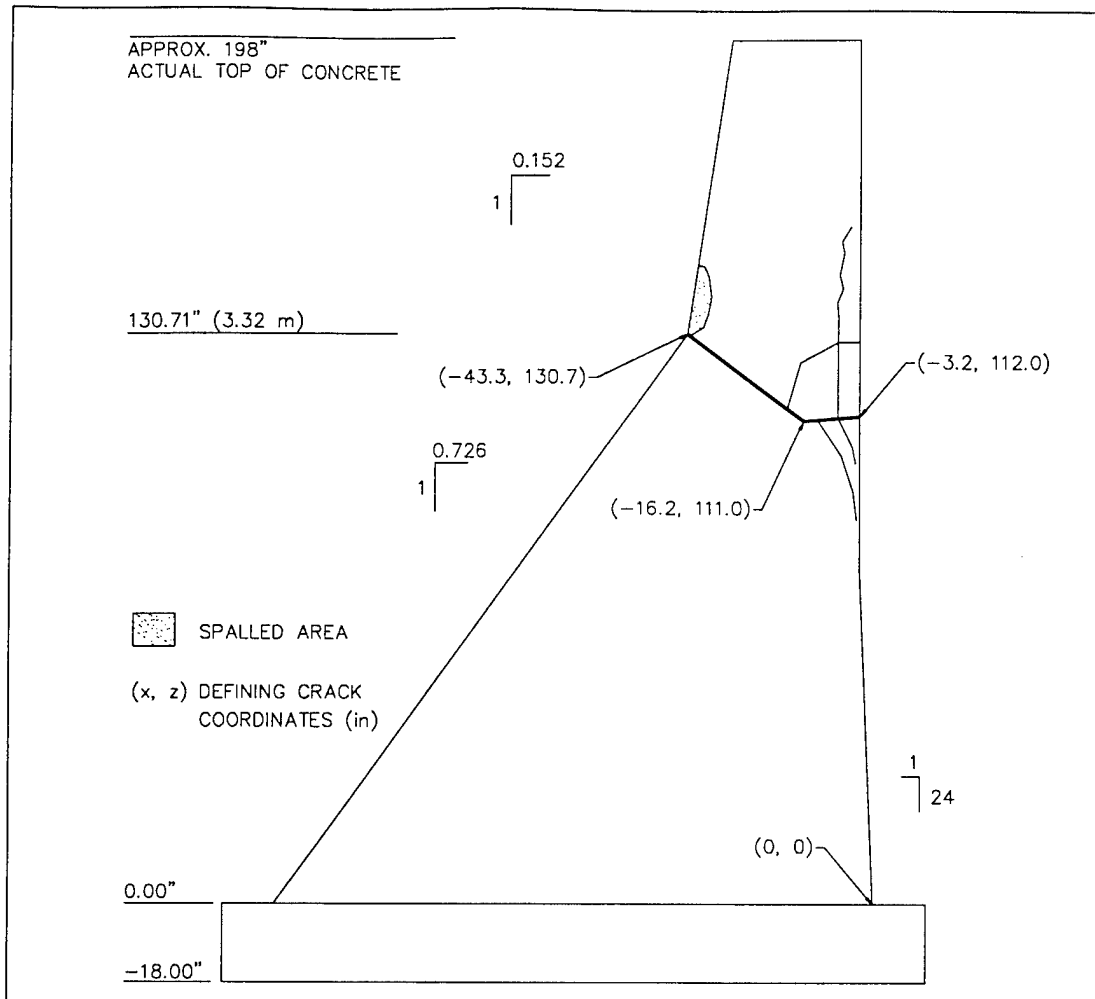
Figure 39. Measured coordinates of primary crack on the back face (with secondary cracks).

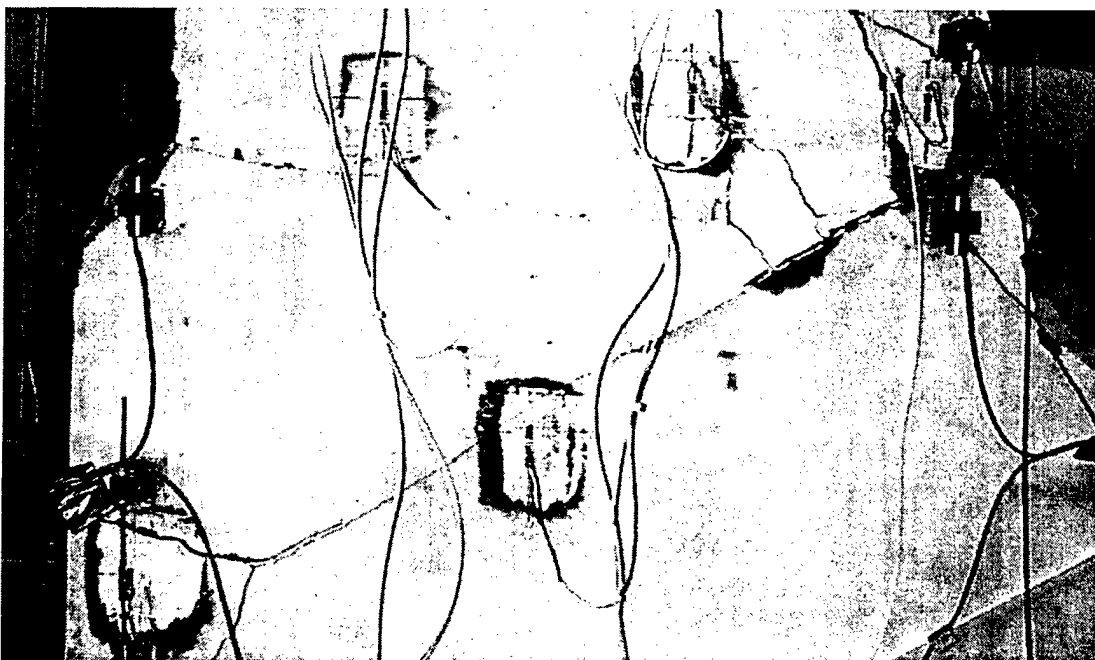
Figure 40. Crack on front face, with horizontal portion on upstream face (left).

Figure 40 shows a similar crack on the front face, with the horizontal portion of the crack on the left (i.e., upstream) side of the photograph. The horizontal portion of the crack in Figure 40 has been highlighted with a marker to make it more visible. Figure 41 shows that the horizontal portion of the crack on this face is 8.3 in. (210 mm) long. Figure 42 shows that the primary crack on the downstream face was very straight at the change in slope. Figure 43 shows the measured location of the primary crack, along with secondary cracks and spalling. Figures 44 and 45 show a similar drawing and photograph for the upstream face. The crack has been highlighted by a marker to make it more visible. Note the horizontal portion of the crack on the back face that can be seen intersecting the upstream face crack on the left side of Figure 45. These figures, plus observations of the crack surface after demolition, indicate that the crack surface was a fairly straight diagonal crack as described above with a horizontal portion near the upstream face.

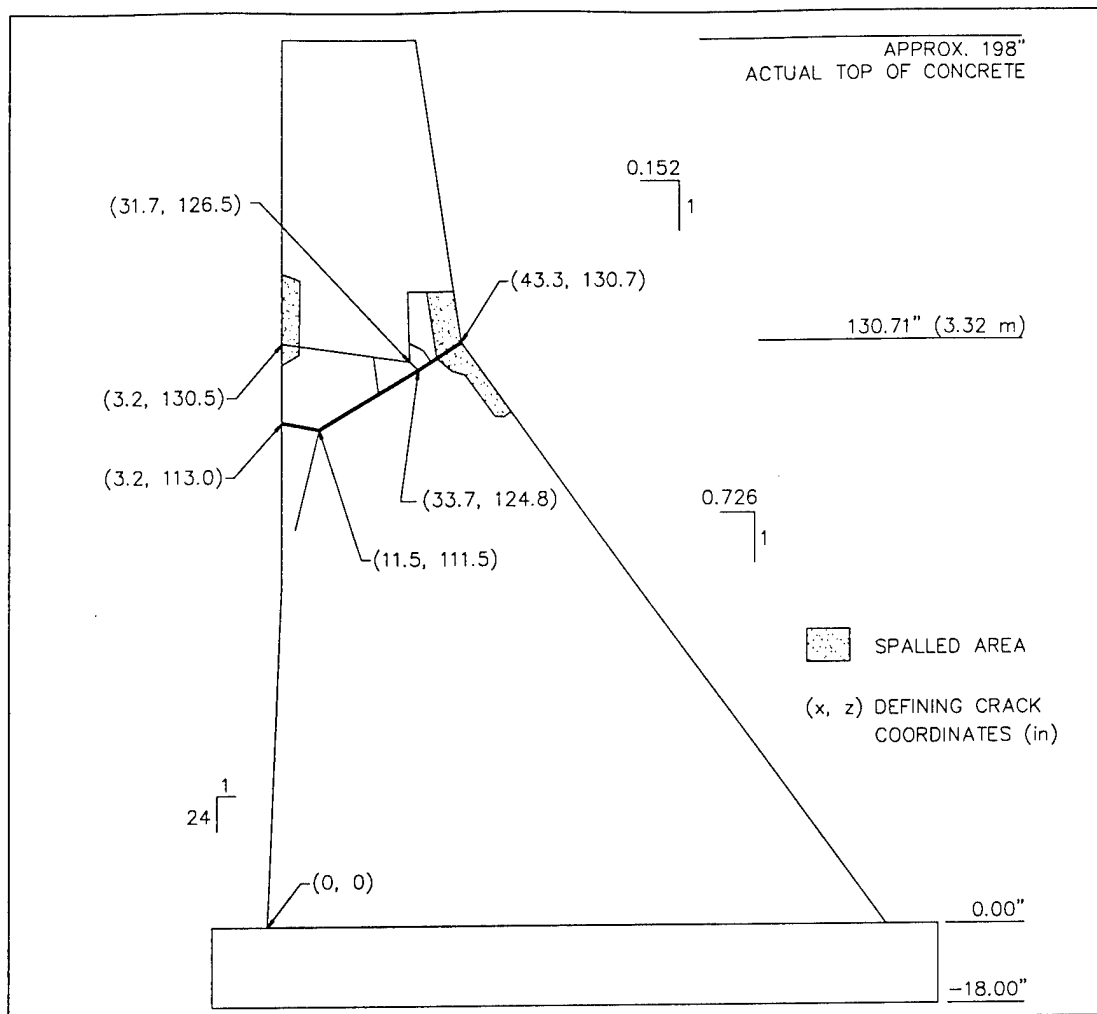
Figure 41. The horizontal portion of crack on front face, measuring 8.3 in. (210 mm) long.

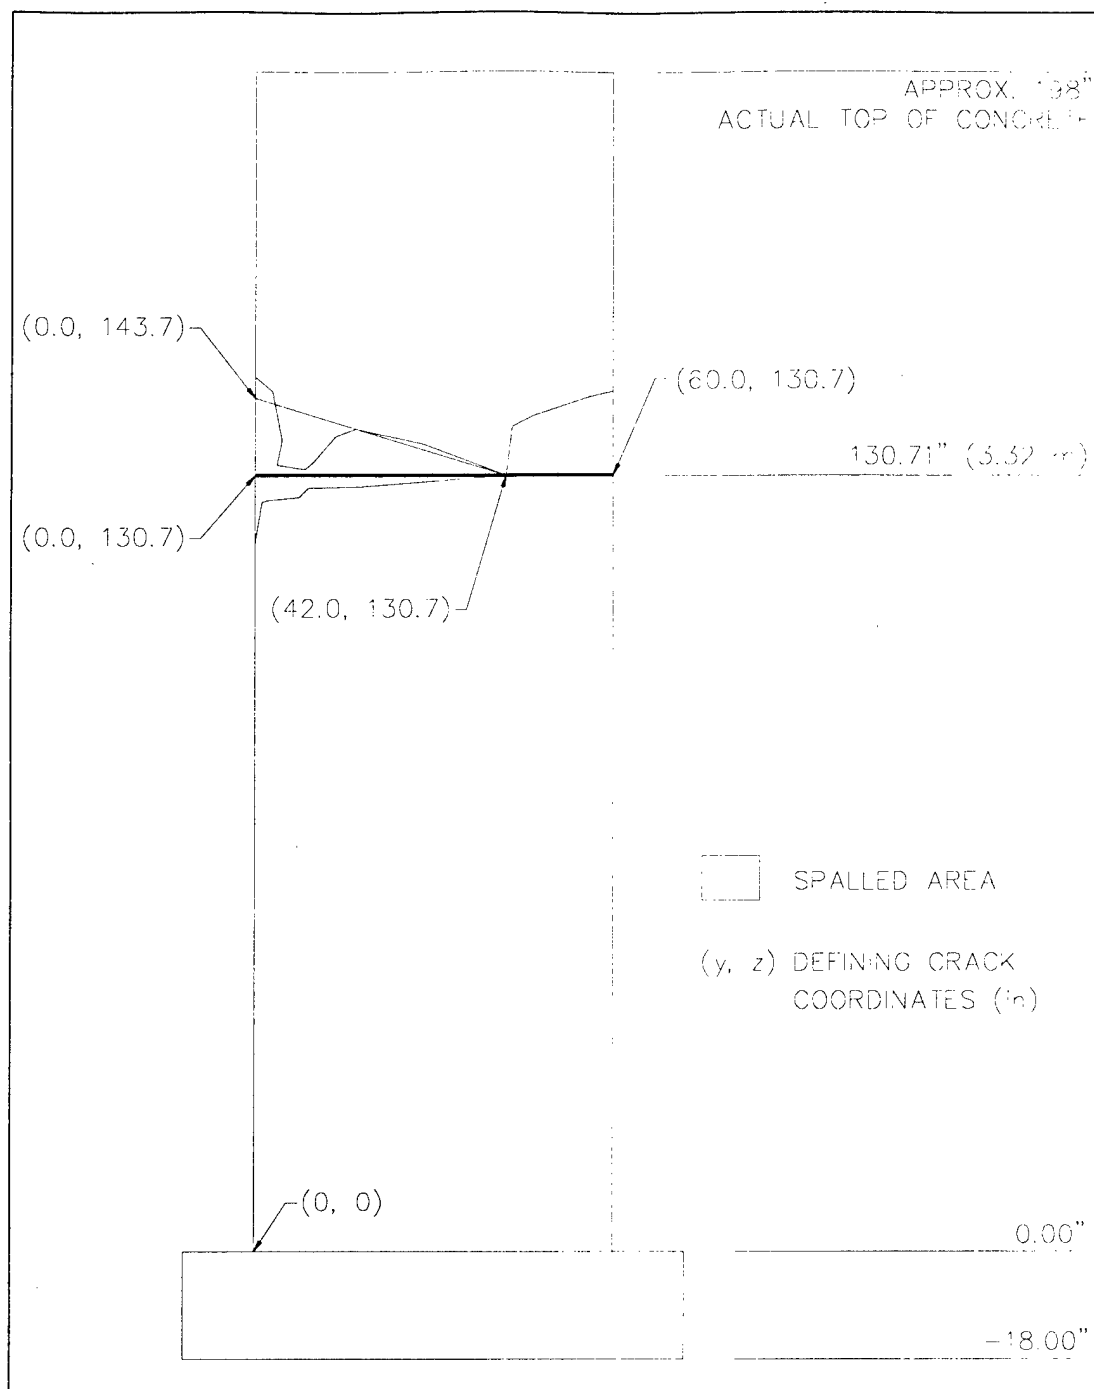
Figure 43. Drawing of the downstream face showing cracks, spalling, and primary crack coordinates.

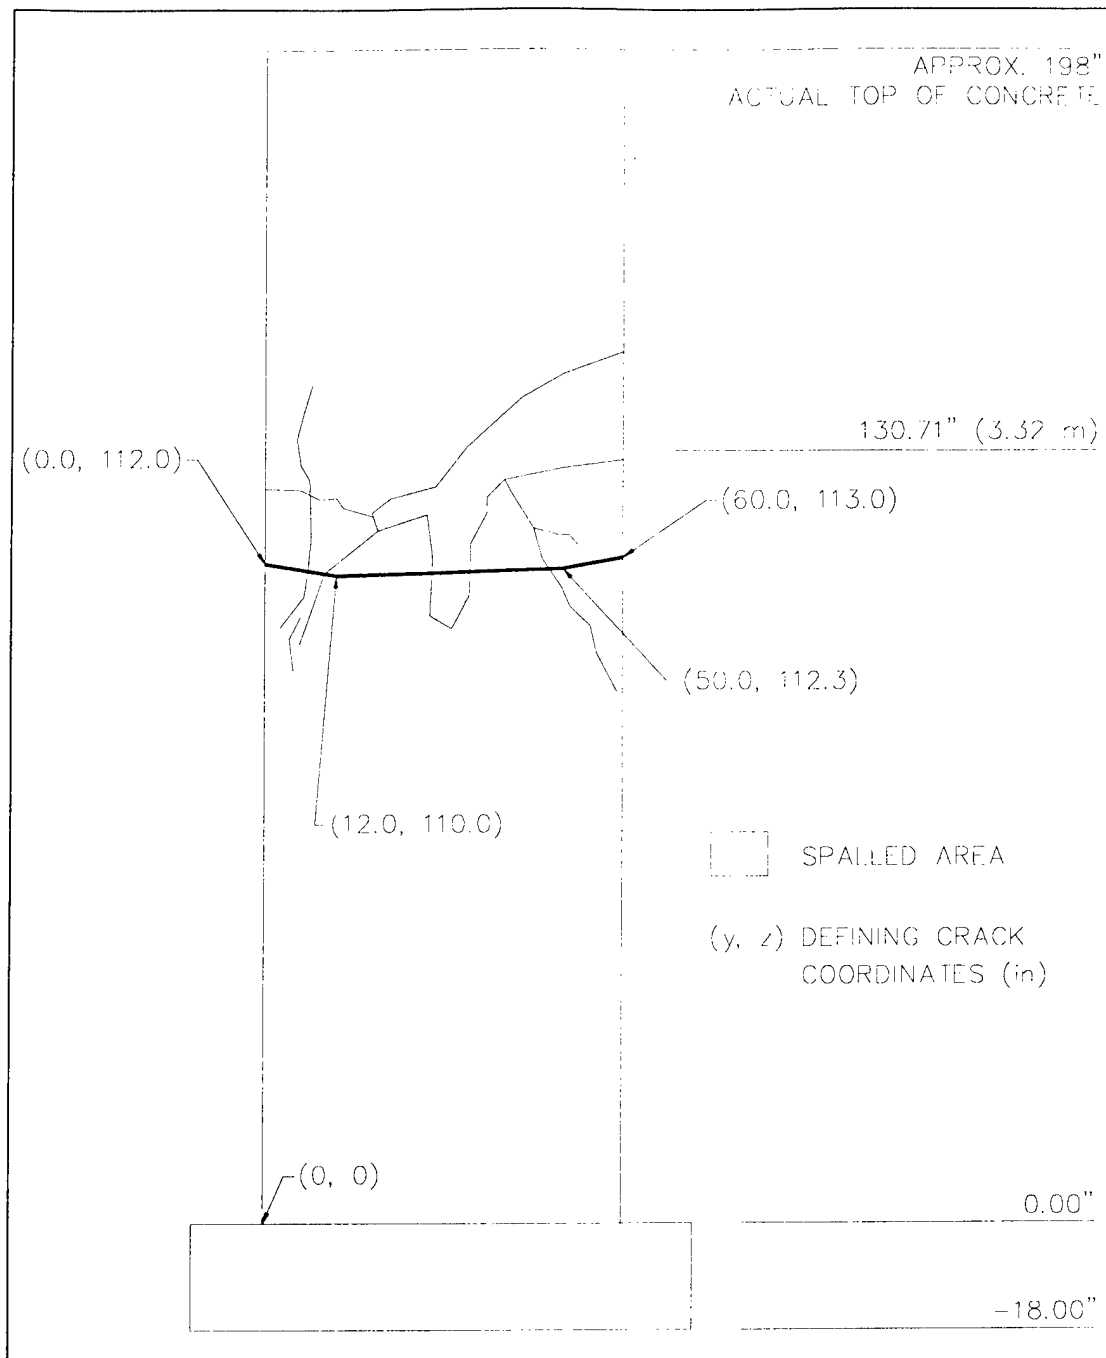
Figure 44. Drawing of the upstream face showing cracks, spalling, and primary crack coordinates.

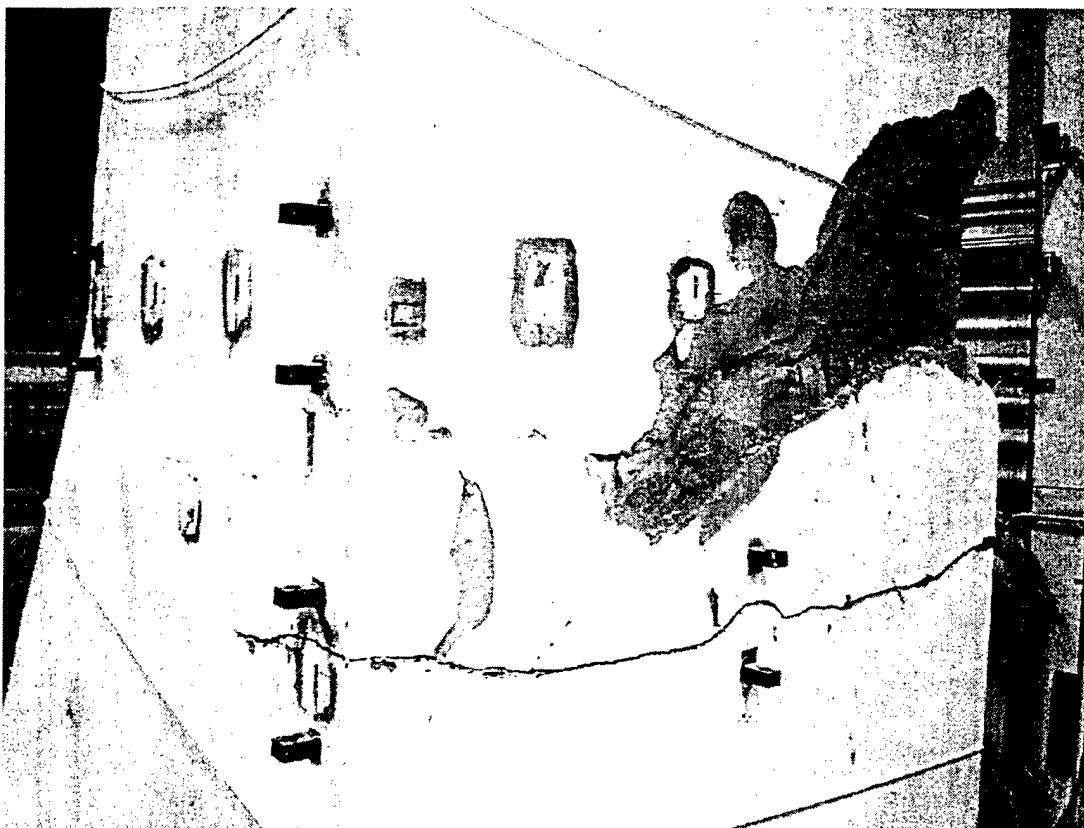
Figure 45. Close-up of the crack on the upstream face of the model.

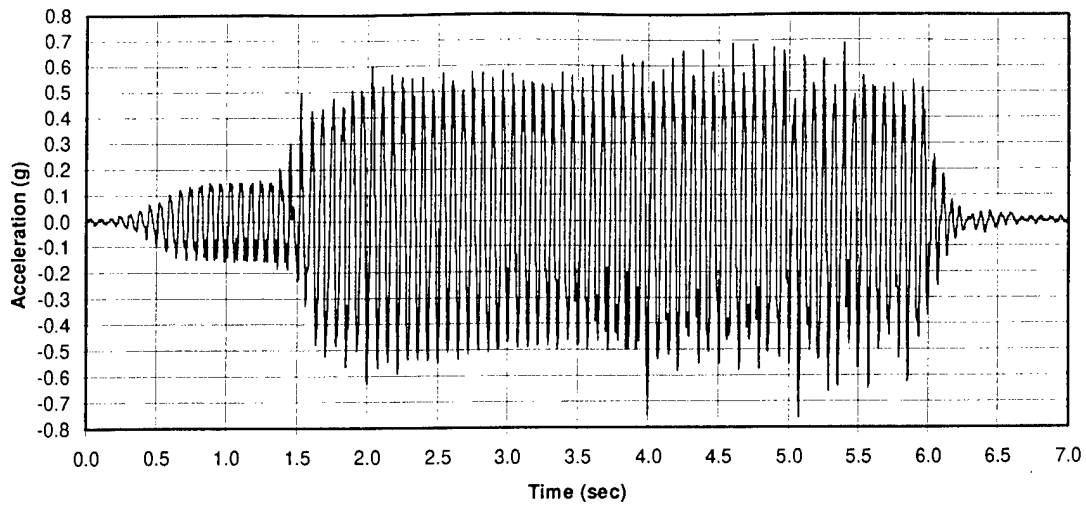
Figure 46. Support motion (A7x) for the Sine6 test.

The support motions for the Sine6 test were identical to Sine5, but at an increased amplitude of 0.16 g. Figure 46 shows the sinusoidal motion at the base of the dam model (A7x) for Sine6. The first 1.4 seconds of this record agrees well with Table 8, showing the 0.16 g amplitude of the sinusoidal motion and a frequency of 14 Hz (0.07 sec/cycle). Figure 47 shows the measured (absolute) accelerations A6x, A7x, A8x, A4x, and A10x for 0.7 through 1.5 seconds. This figure shows that the upstream accelerations reached a steady-state response at 0.8 seconds and maintained those levels until crack initiation near 1.4 seconds, indicating linear model response and no damage until that time. Table 10 provides the peak measured accelerations along the upstream face (A6x, A7x, A8x, A4x, and A10x) before the initiation of the failure. For each peak value shown in Table 10, the sensor number, measurement location, and time of measurement are given. The dam model quickly reached a steady state response, before cracking, as seen in Figure 47. The average of the peak steady-state response from each cycle best reflects the response of the model, and an estimate of this value is given in Table 10. This table provides a summary of the peak linear response for each sensor measured during the Sine6 test before cracking.

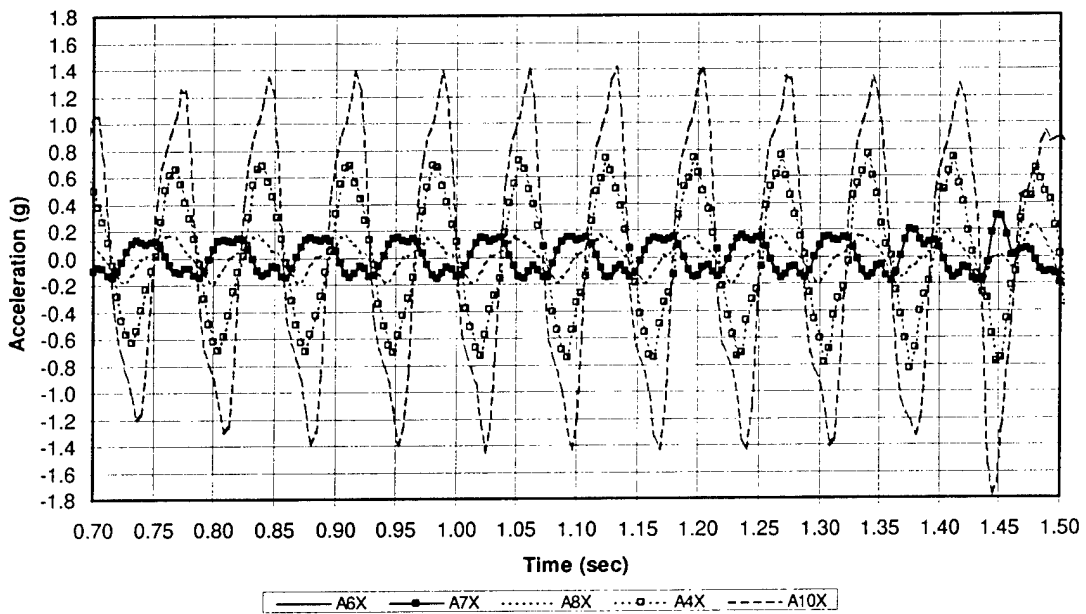
Figure 47. Sine6 measured accelerations at the base beam, model base, and elevations of 50.8 in., 129.5 in., and 195 in. for 0.7 through 1.5 seconds.

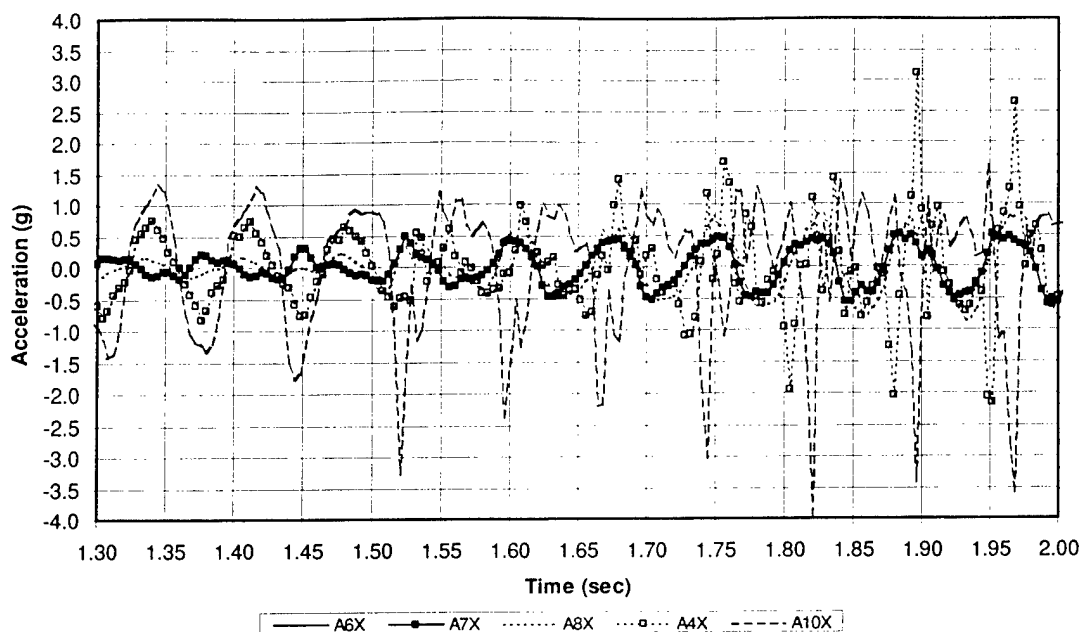
Figure 48. Sine6 measured accelerations at the base beam, model base, and elevations of 50.8 in., 129.5 in., and 195 in. for 1.3 through 2.0 seconds.

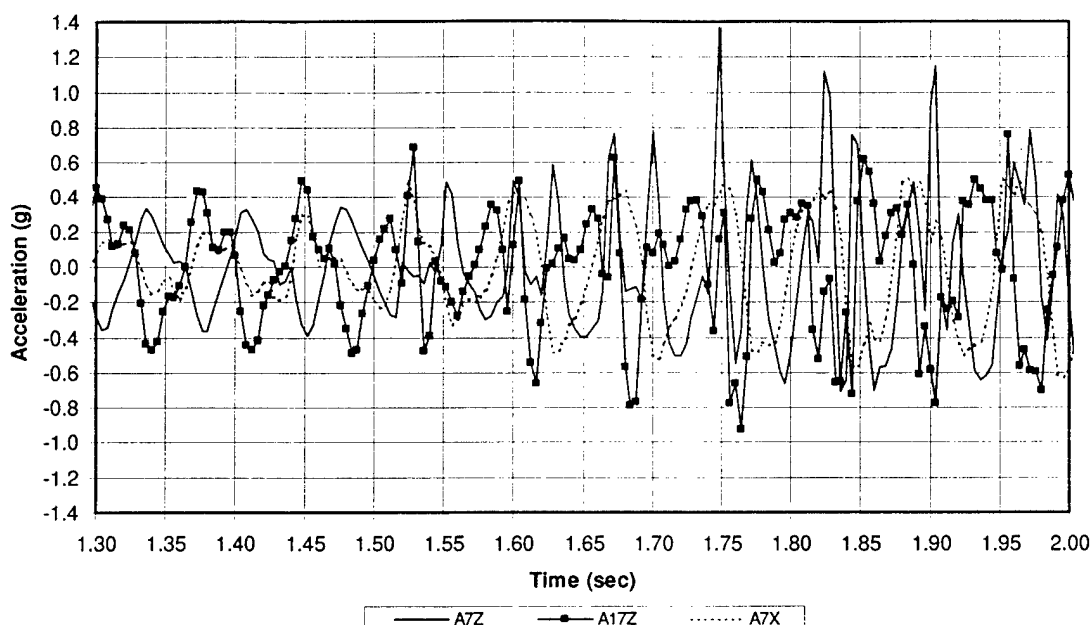
Figure 49. Sine6 overturning accelerations relative to in-plane horizontal accelerations.

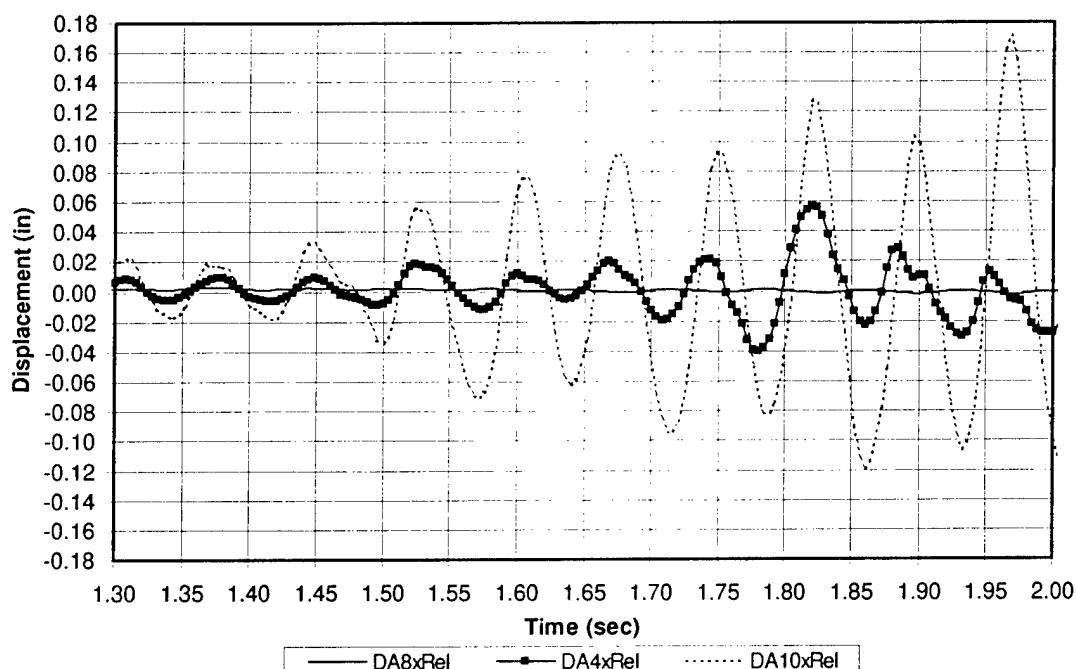
Figure 50. Relative displacements along upstream face showing dam distortions for Sine6 test.

along the upstream face ( $DA8x_{Rel}$ ,  $DA4x_{Rel}$ , and  $DA10x_{Rel}$ ) are plotted in Figure 50 for the 1.3 to 2.0 second region of the Sine6 test. This plot shows that the deformations of the model represented by the relative displacements remain constant until 1.43 seconds. Table 10 provides the peak relative displacements along the center of the upstream face ( $DA8x_{Rel}$ ,  $DA4x_{Rel}$ , and  $DA10x_{Rel}$ ), before crack development. Table 10 also provides an average steady-state response of the relative displacements.

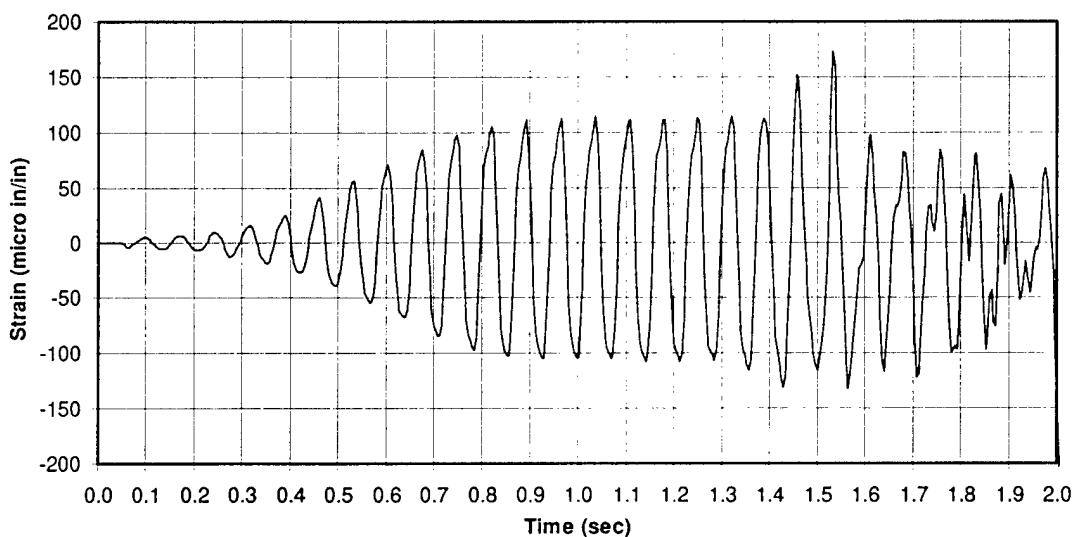
Figure 52. Sine6 strain measurements along the upstream face at S3z only.

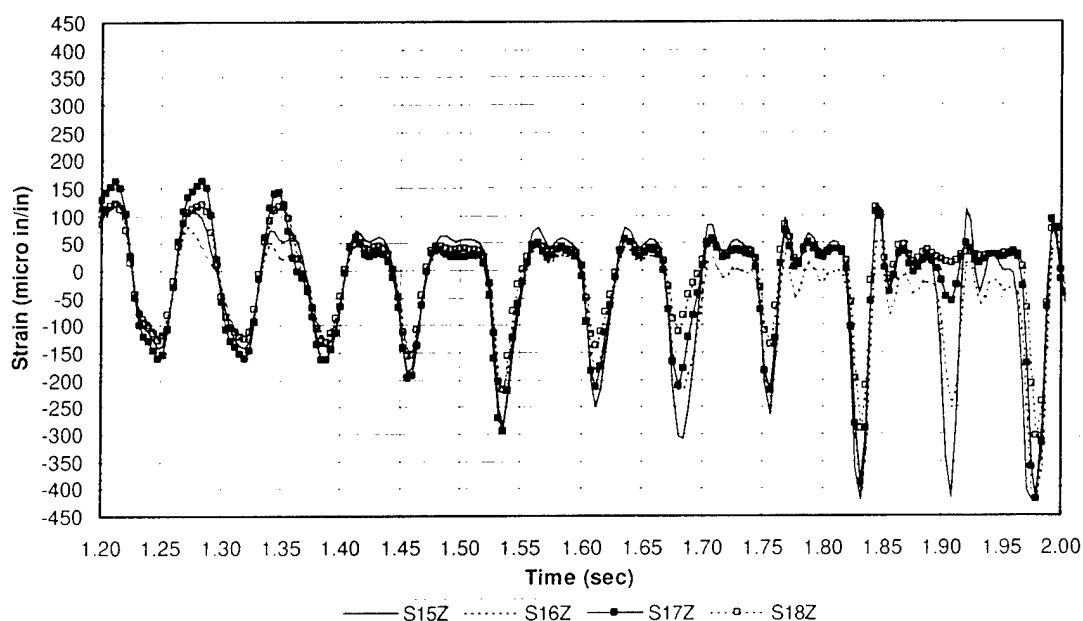
Figure 53. Sine 6 strain measurements along the downstream face.

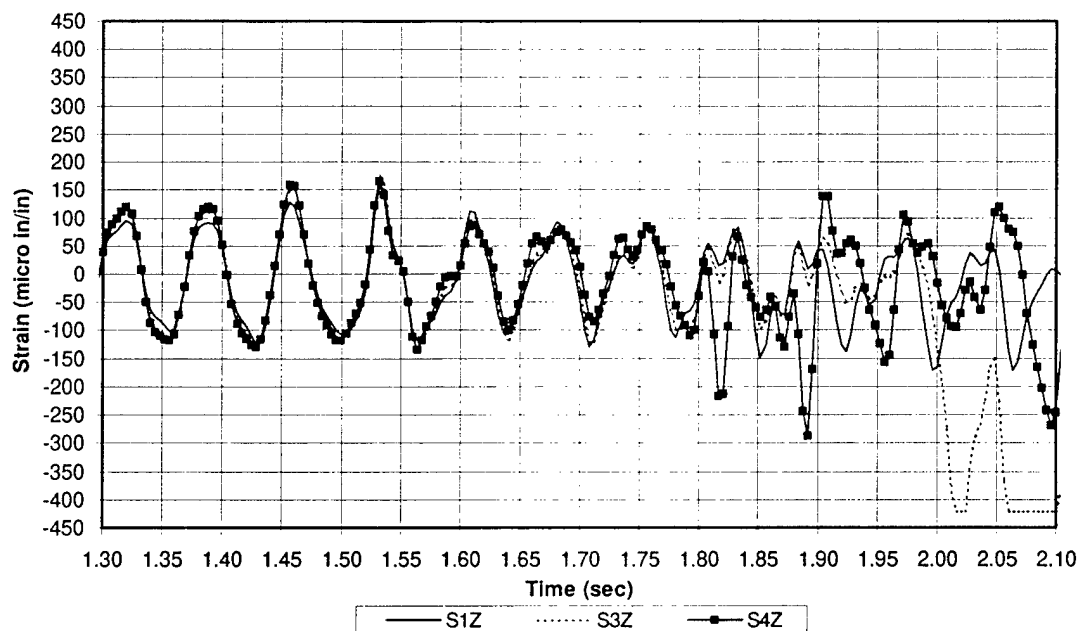
Figure 54. Sine6 strain measurements along the upstream face.

Figure 54). Because the dam model is responding in bending, the upstream face strain gages are in tension when the downstream gages are in compression. Therefore, the downstream compression spike at 1.45 seconds (see Figure 53) that resulted from the crack forming on downstream face causes a related tension spike on the upstream face. The amplitude of the next downstream compression spike grows in the next cycle, at 1.53 seconds, due to greater impact loading, and the amplitude of the related tension spike shown in Figure 54 also grows at 1.53 seconds. Figure 54 also indicates that at 1.56 seconds the compression (negative in Figure 54) side of the oscillation loses its previously rounded shape, creating a compression spike. This indicates that the crack has propagated all the way through the dam cross-section to the front face at 1.56 seconds because the compression spike was probably created by impact as the crack closed.

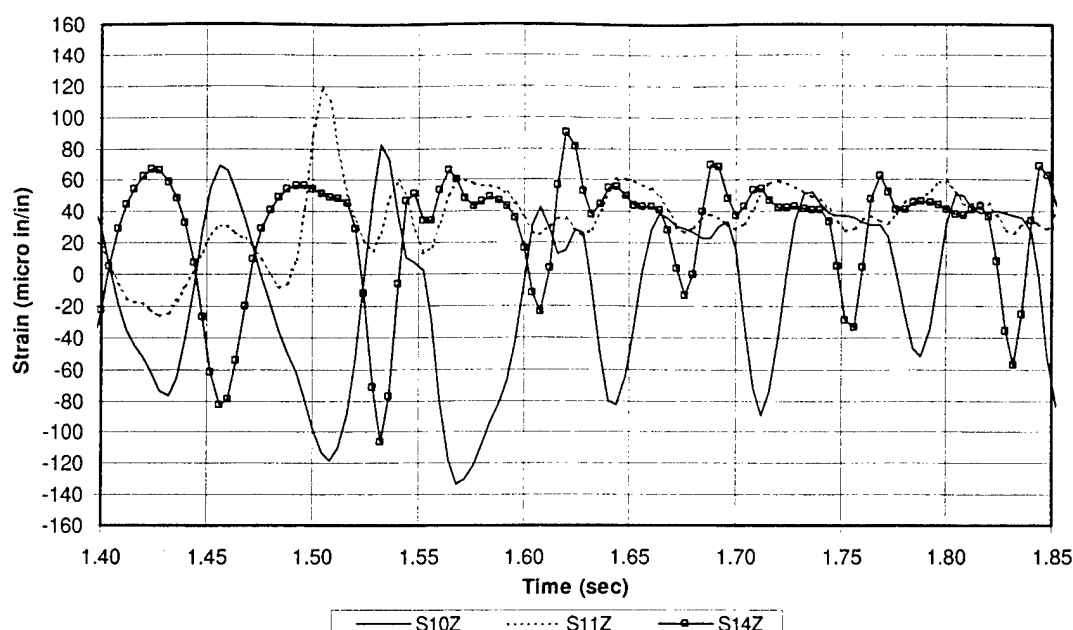
Figure 58. Sine6 back face strains for 1.4 to 1.85 seconds.

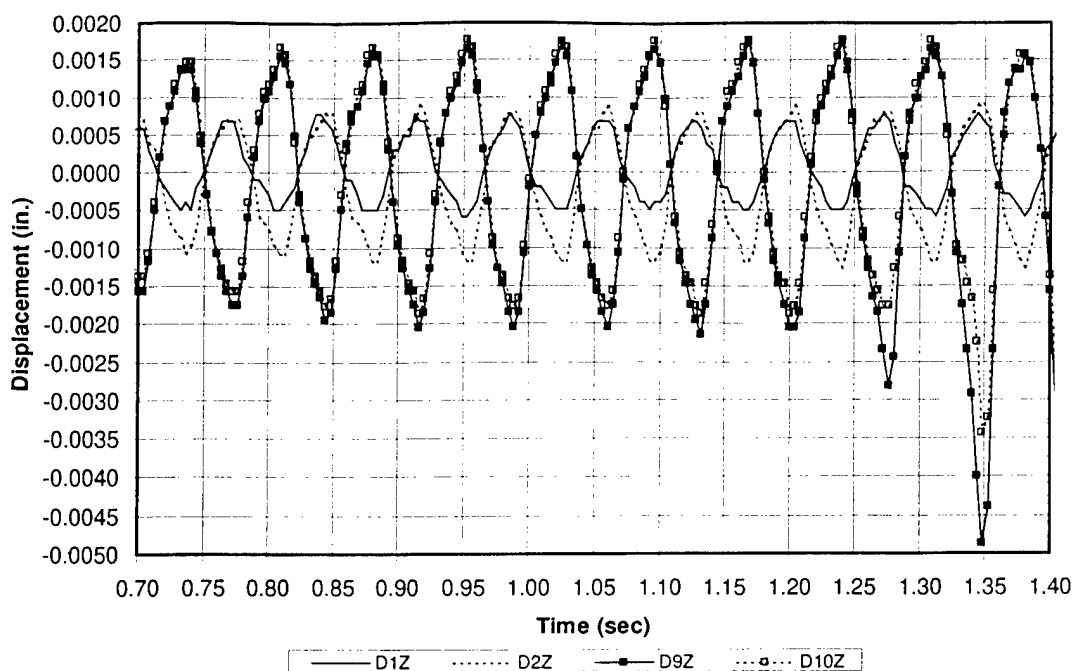
Figure 59. LVDT measurements at both the downstream and upstream faces of the Sine6 test.

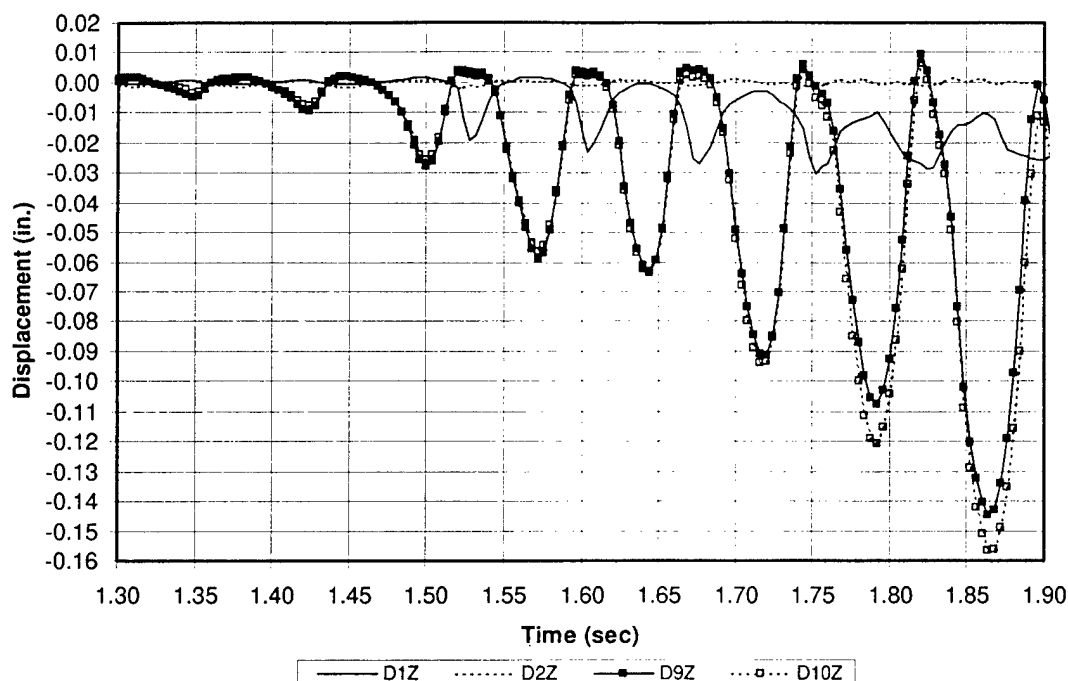
Figure 60. Sine6 LVDT measurements at upstream and downstream faces, 1.3 to 1.9 seconds.

Figure 60 shows that the crack on the downstream face continues to open more with each cycle, eventually reaching a peak opening of 0.151 in. (3.83 mm) at 1.864 sec. This peak opening was calculated from the average of the peak deformations at D9z and D10z shown in Figure 60. The peak opening should equal the peak deformation once the crack opens (i.e., no correction for the deformation prior to crack development) because the material near the crack will be relieved of stress and strain once the crack opens.

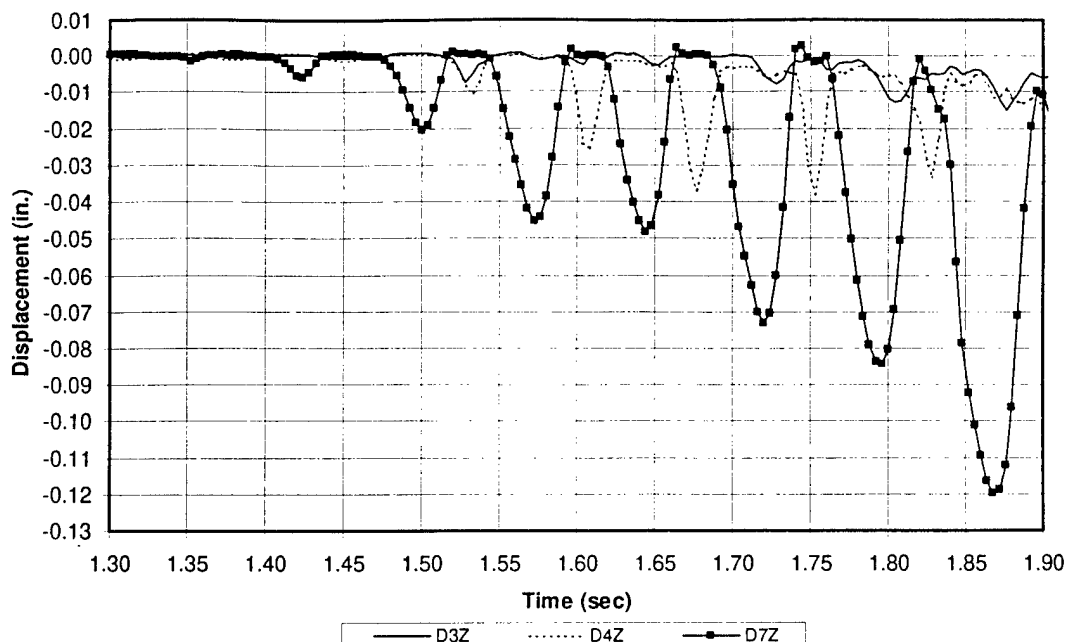
Figure 61. Sine6 LVDT measurements for the front face.

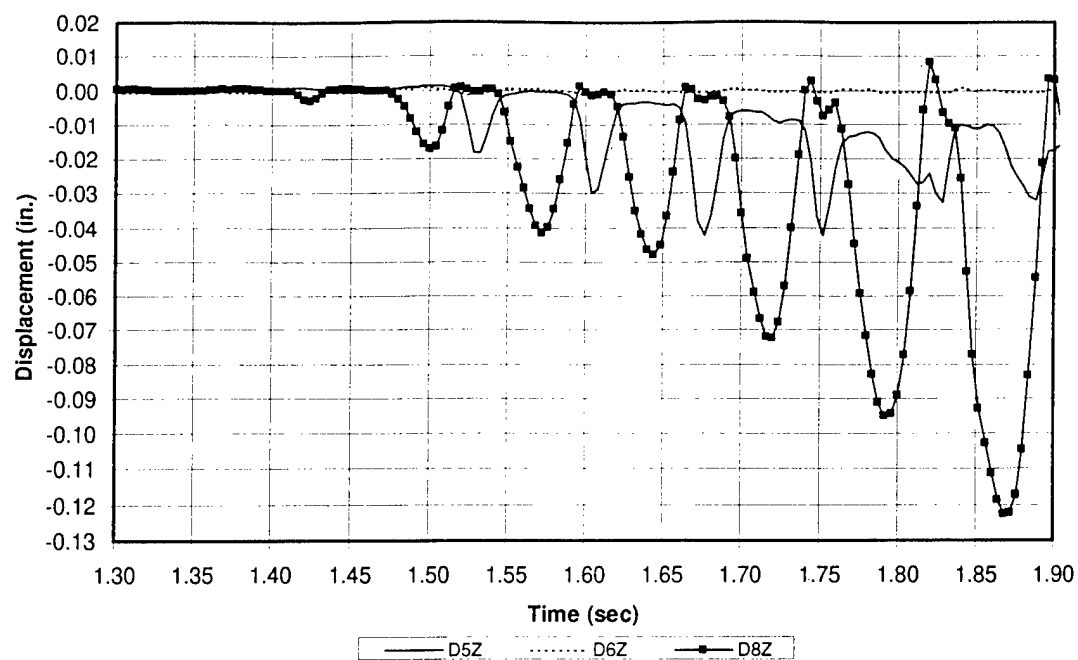
Figure 62. Sine6 LVDT measurements on the back face.

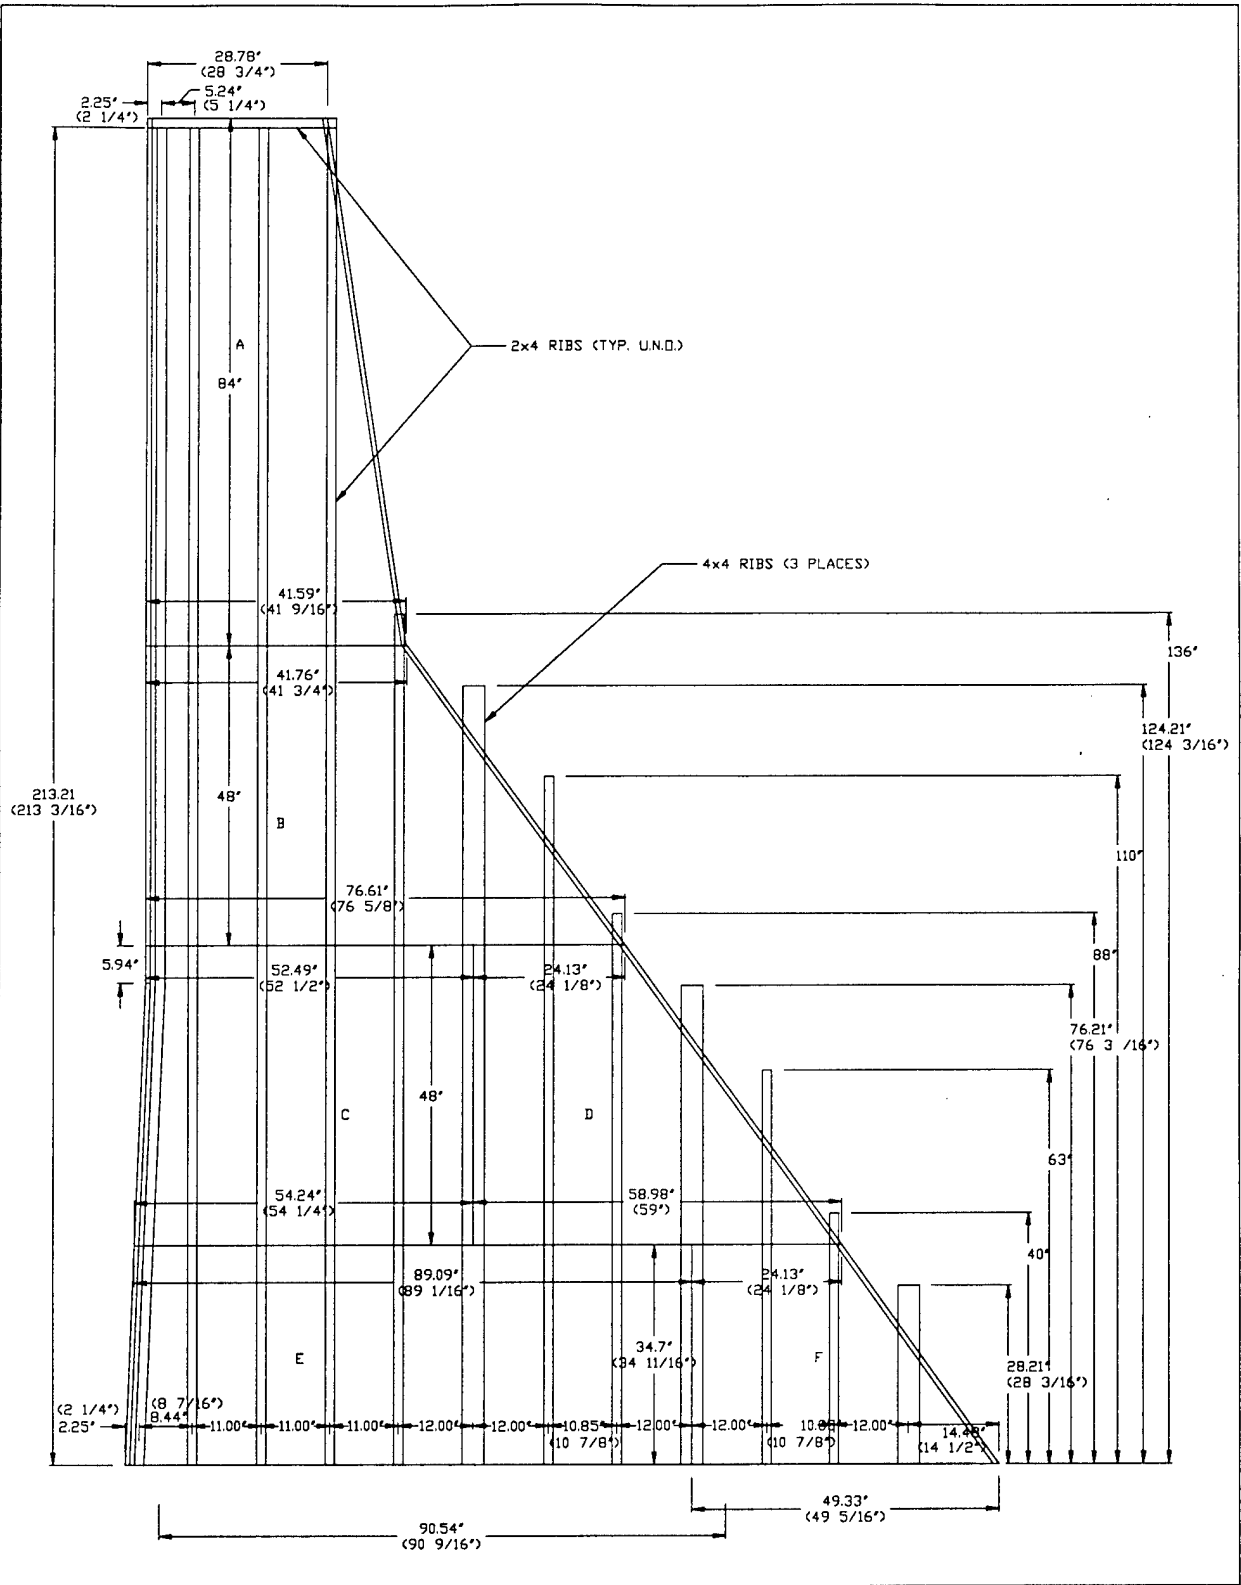
Figure A3. Front face drawing of model formwork showing MDO board and vertical ribs.

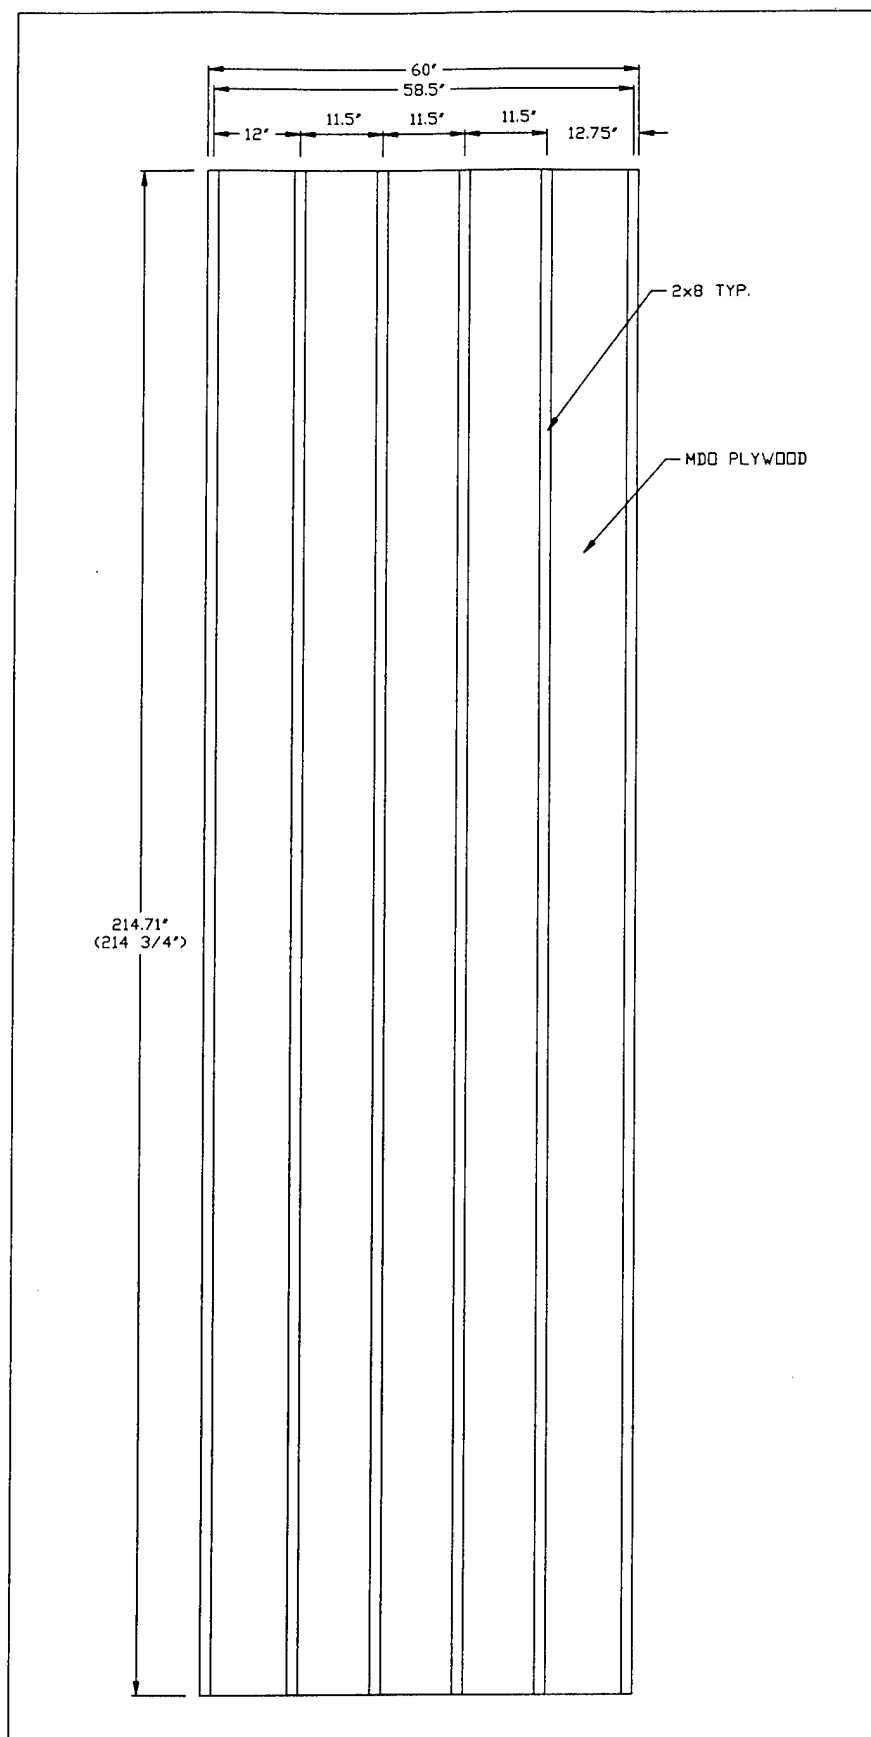
Figure A4. Drawing of upstream face formwork showing the MDO board and 2 x 8 vertical ribs.
